Manhole Inspection Summary

Manhole # S51M__013MH

Insp Date: **4/3/08 8:50 AM**

Location Address: **934 s. curley**

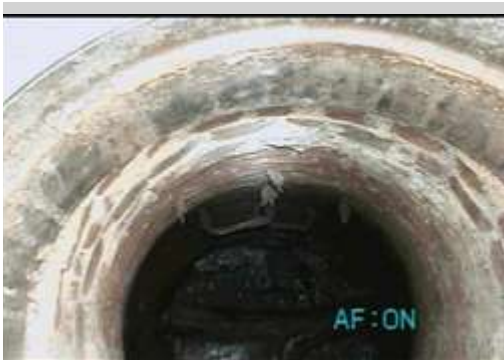
Defect 2

Count: **6** Missing: **2** ☒ **Corroded**

steps

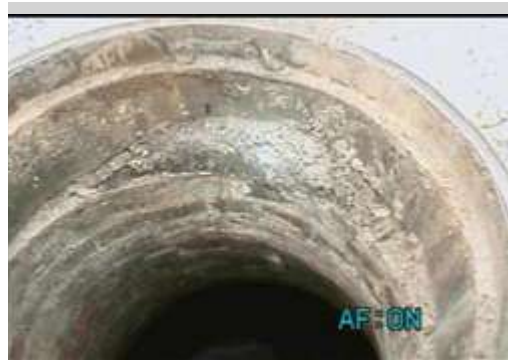
Defect 1

Offset: **3** (in.)

Condition: ☐ Sound ☐ Cracked ☐ Root Intrusion ☐ Loose Brick ☒ **Deteriorated**

chimney deteriorated and offset

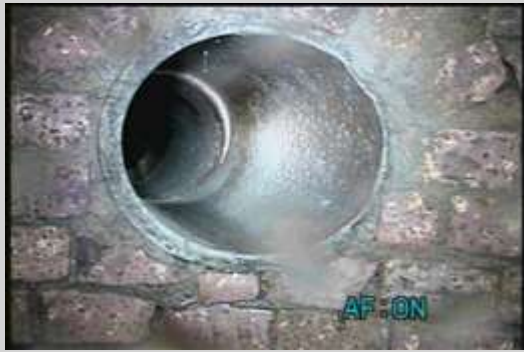
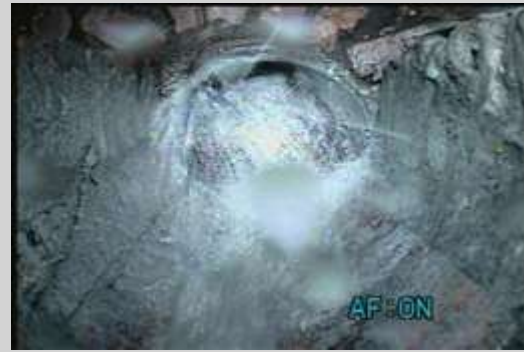
7 O'Clock Inflow

couldnt get better picture water splashing from invert

Drop: **Outside Direct**

Drop Condition: **Open**
